Surgical removal of a fractured balloon catheter from deep femoral artery: a case report

ABSTRACT

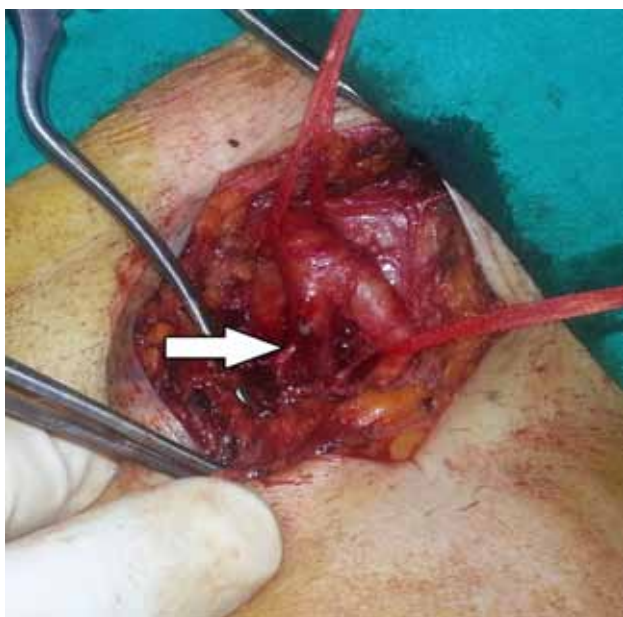
Figure 1. An intraoperative image. Arrow shows a broken balloon catheter into the deep femoral artery.

A 71-year-old man was admitted our hospital with a pain on the right inguinal area for a month after a coronary intervention via the right femoral artery. Doppler ultrasound confirmed a pseudoaneurysm originating from the deep femoral artery, which was measured 100x70x50 mm in size. An endovascular treatment was planned. The interventionists placed a covered stent across the hole in the arterial wall to prevent blood flow from the deep femoral artery to the pseudoaneurysm sac. However, it broke down from the neck during retrieval of the balloon catheter. The interventionists tried several attempts to snare it out; however, all attempts failed. The patient was referred to us for surgery. A written informed consent was obtained from the patient. Following the skin incision, a large hematoma was seen and, then, drained. The common femoral artery and distal portion of the deep femoral artery were freed with careful dissection and nylon tapes were placed around the vessel (Figure 1). The broken end of the balloon catheter was seen into the deep femoral artery and removed (Figure 2). The

artery was, then, repaired with 6-0 prolene sutures. The procedure was performed under local anesthesia. After surgery, the patient was followed for three days in the ward and, then, he was discharged.

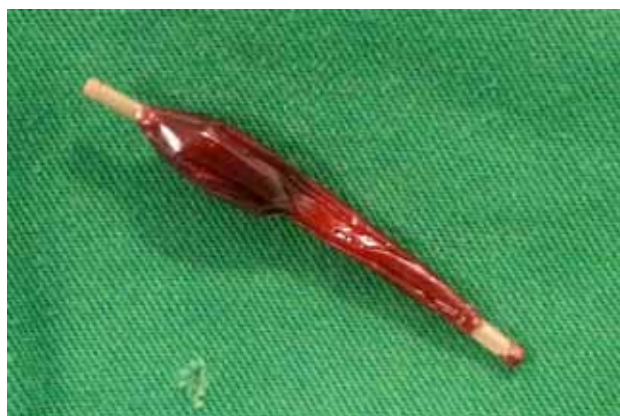
Figure 2. The broken balloon catheter.
